**Site Reassessment
Mesa I, Mines 10-15
Abandoned Uranium Mine
Apache County, Arizona**

January 2014

**Prepared by:
Weston Solutions, Inc.
1340 Treat Blvd
Suite 210
Walnut Creek, CA 94597**

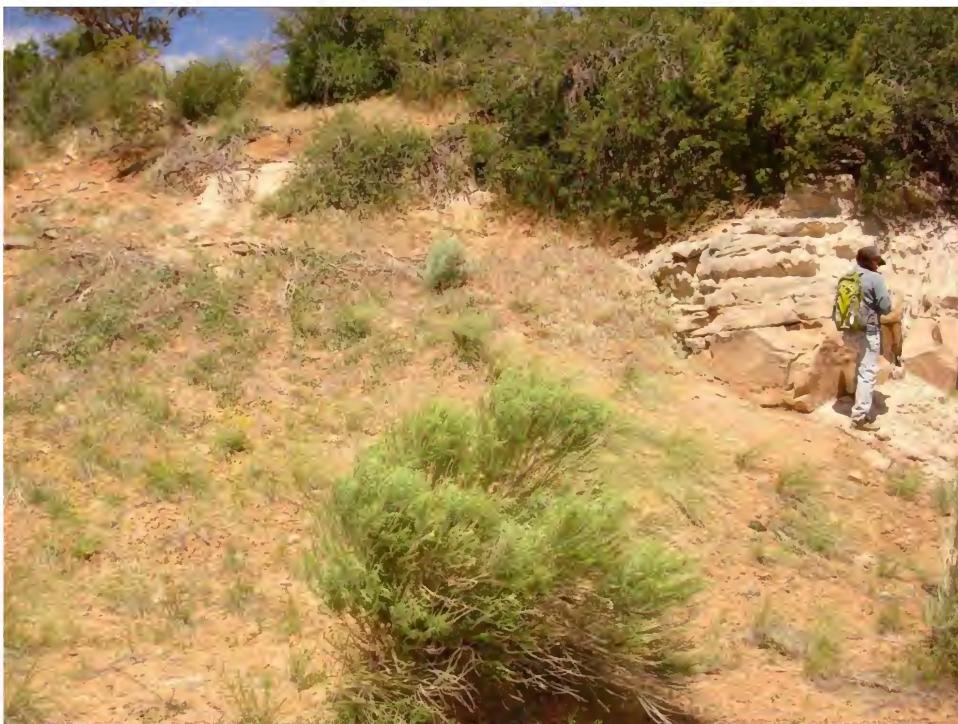
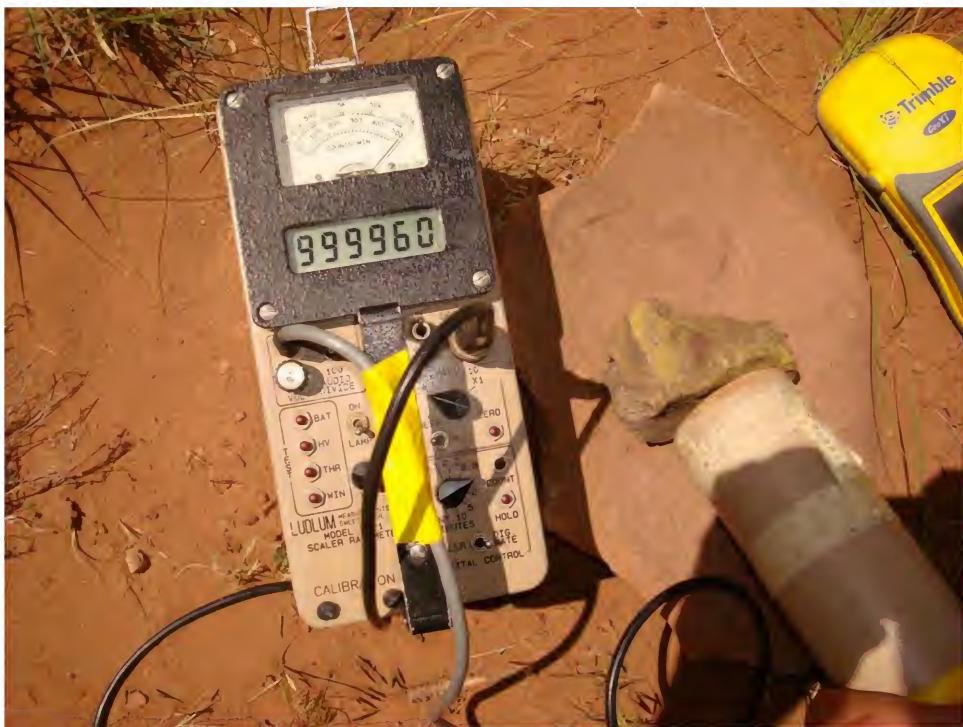
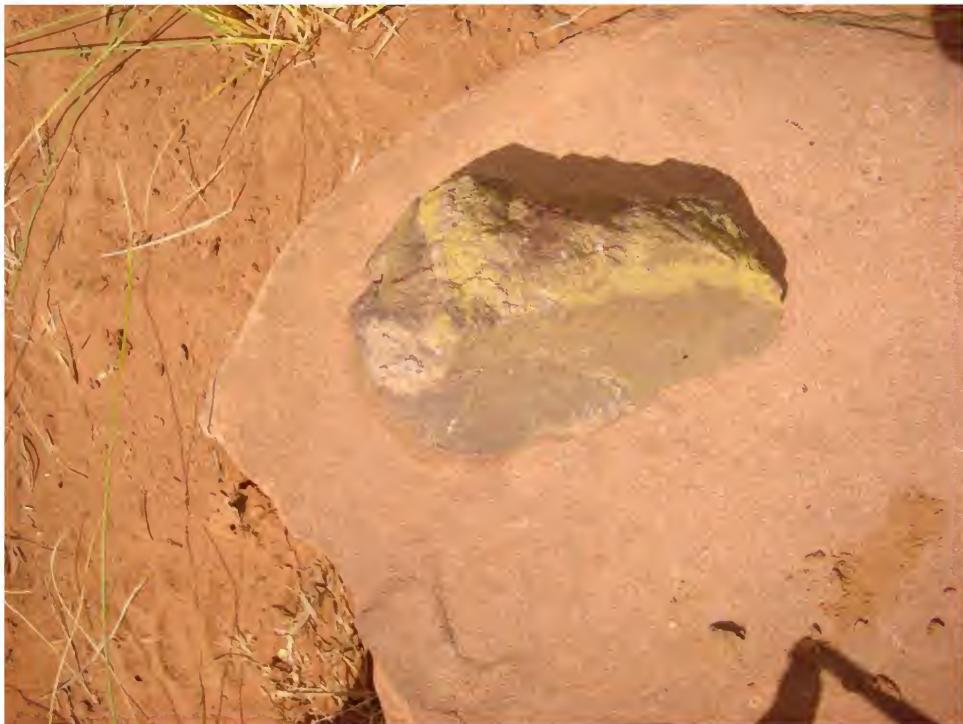
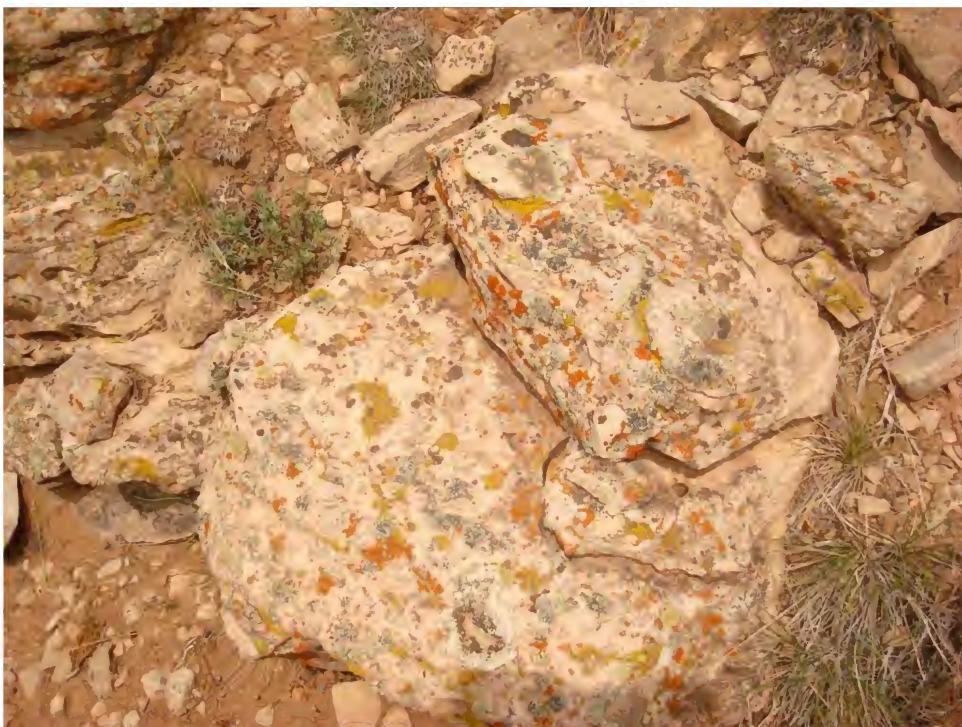
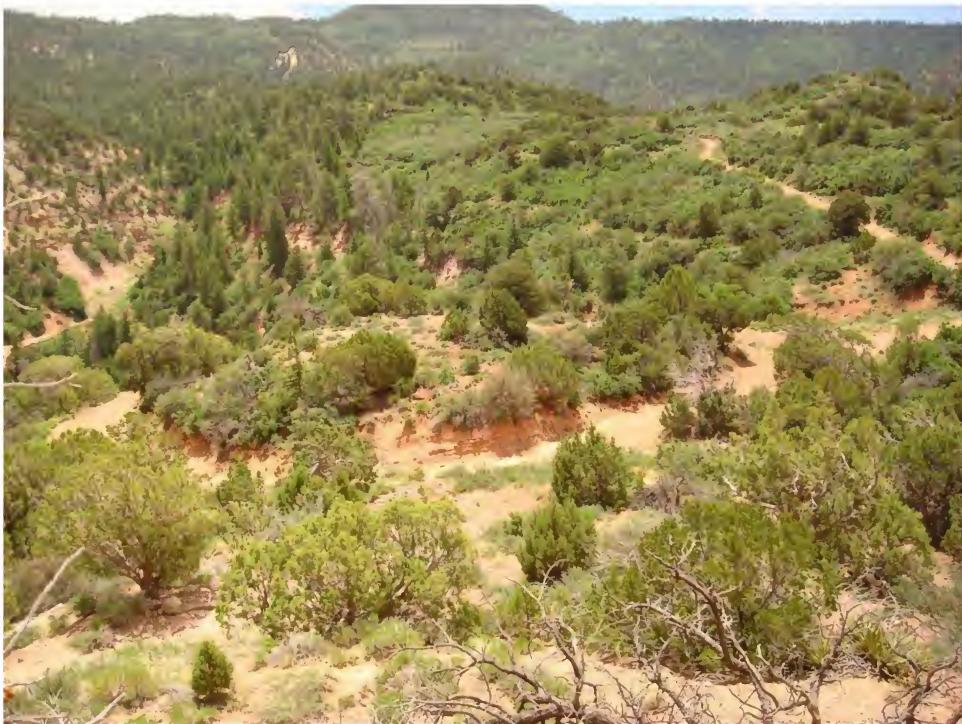
A total of 611 gamma radiation measurements were collected from the mine site, ranging from 10,470 cpm to 999,960 cpm.

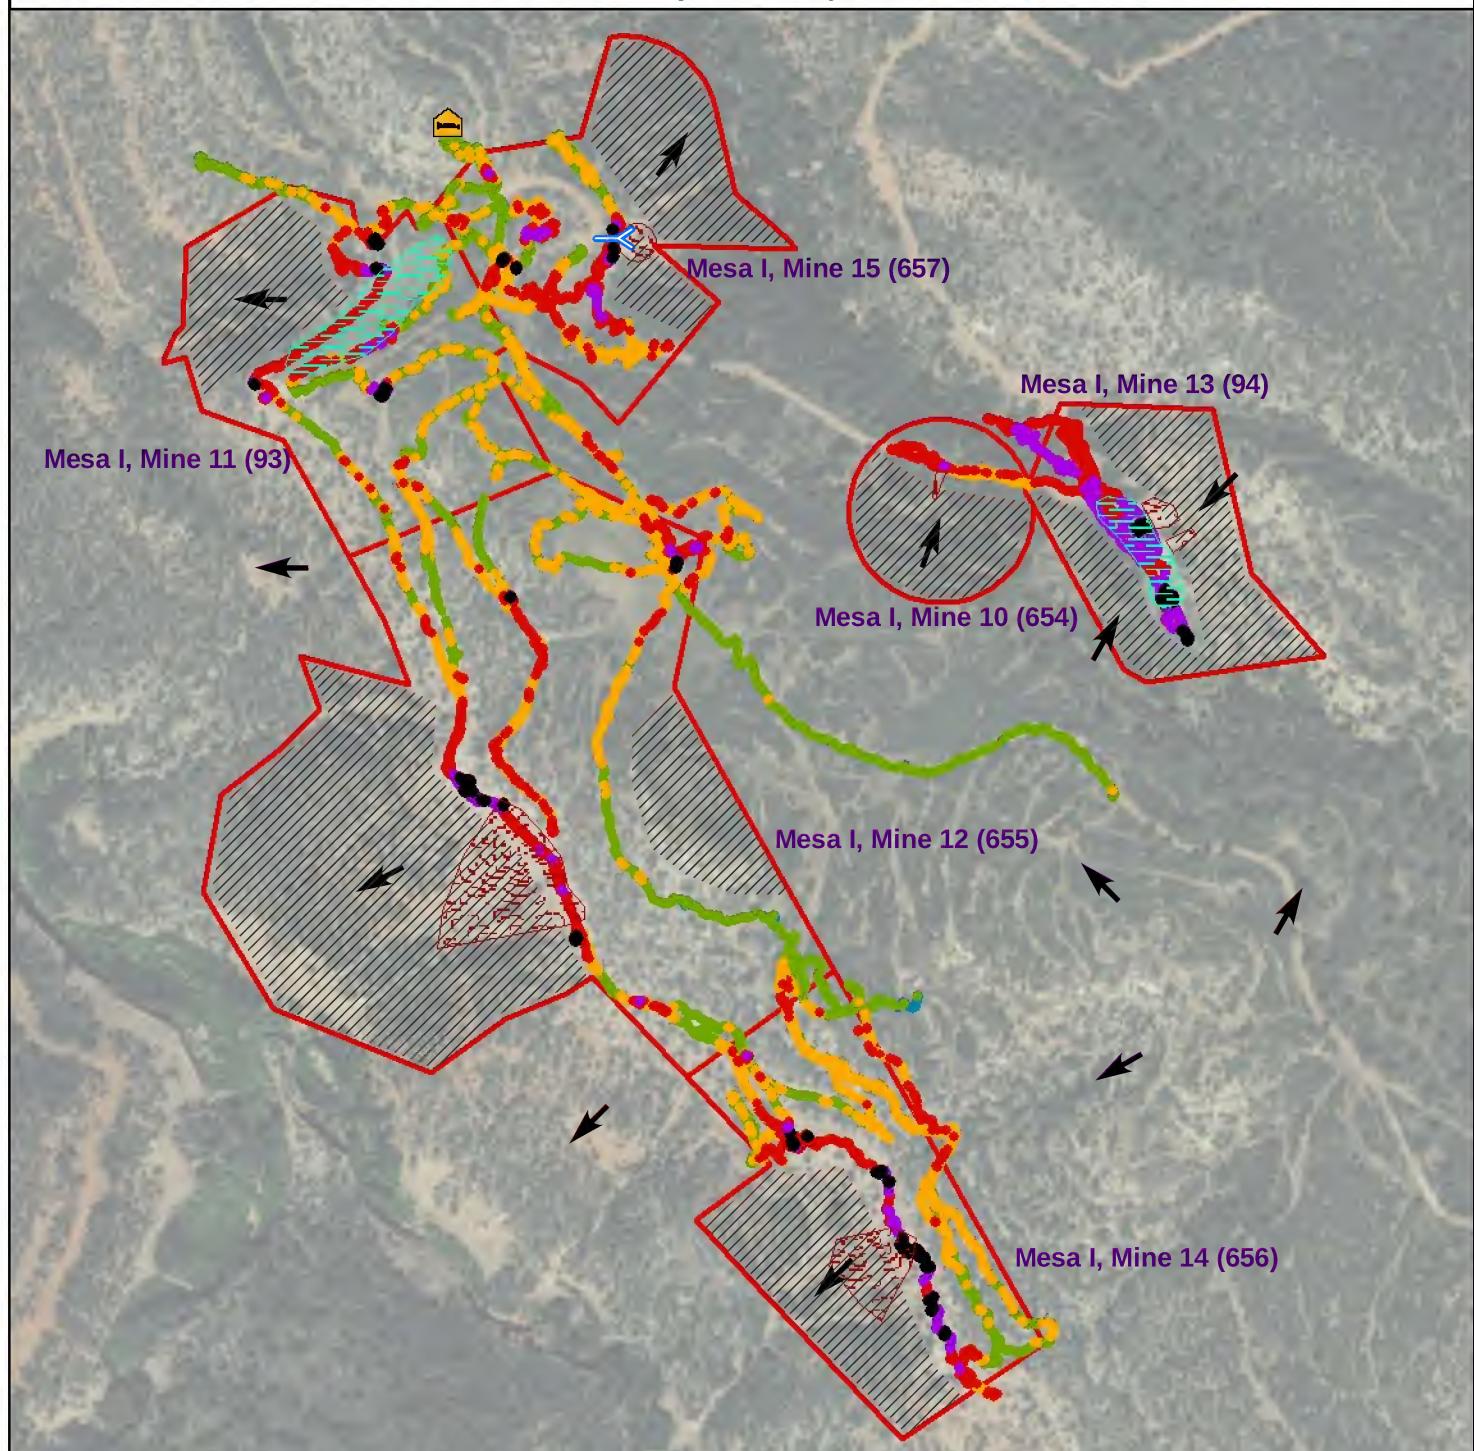
Figure A-2 - Gamma Radiation Measurements
Mesa I, Mine No. 10 - 15 (93, 94, 654, 655, 656, 657)
Cove Chapter, Navajo Nation

Gamma survey conducted 06/2010
 Measured as counts per minute (cpm)
 Average background 14,348 cpm
